# What do we know about the Cheonan?

J.J. Suh

# Did a NK torpedo sink the Cheonan Ship ?

Seung-Hun Lee

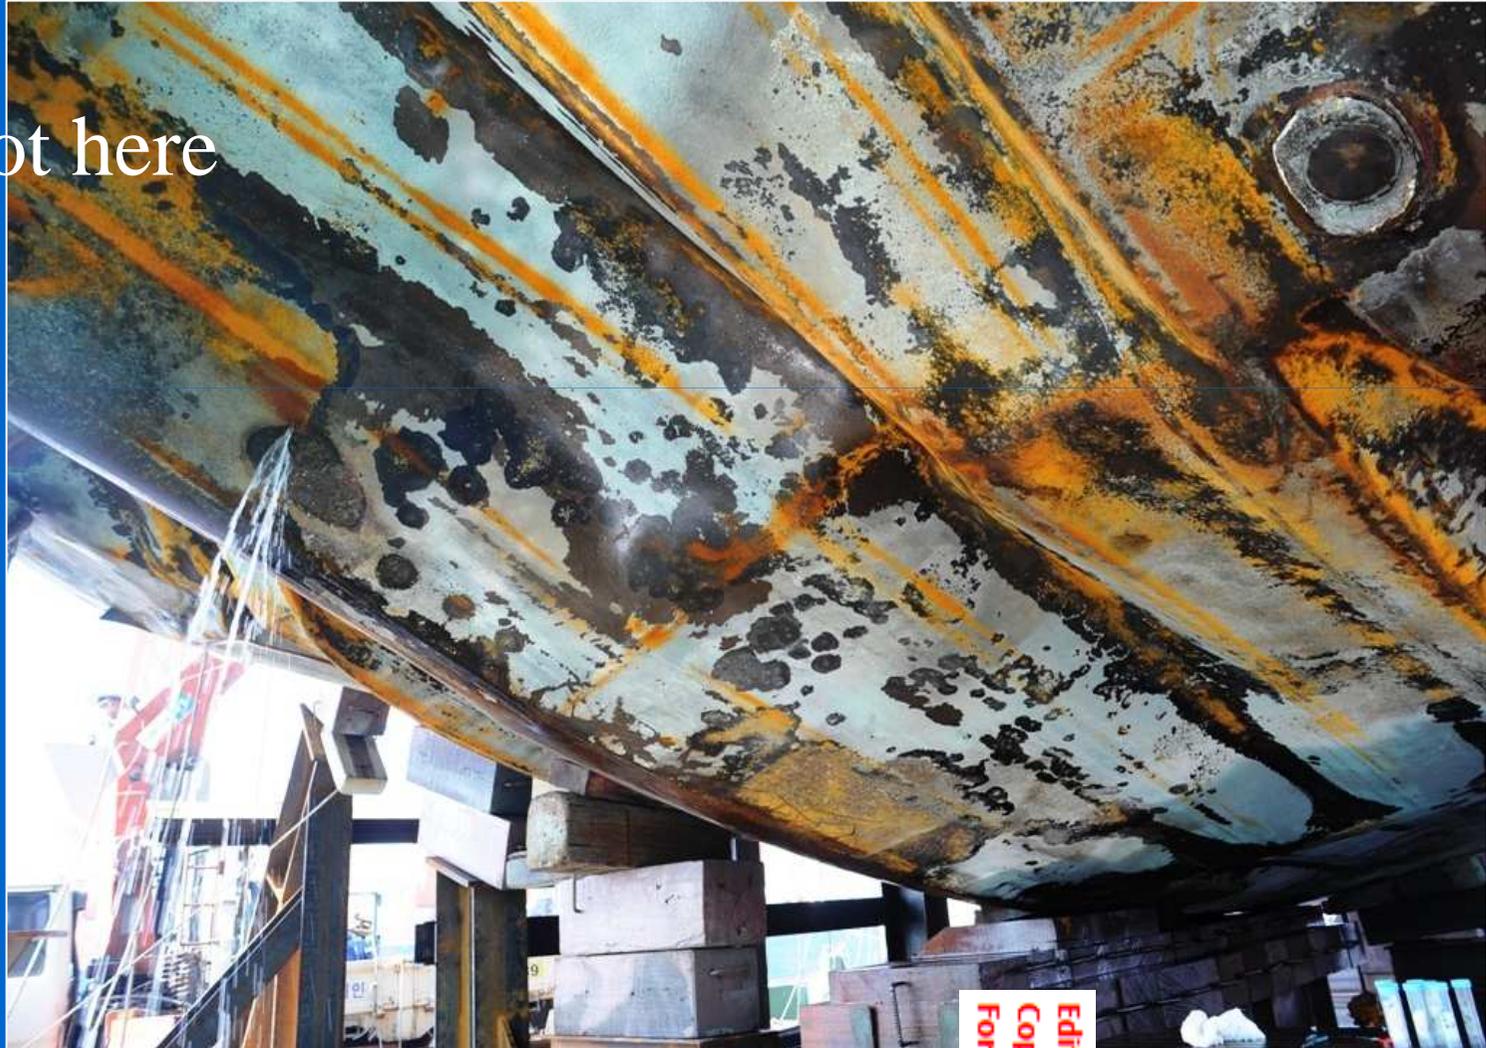
# Where are Fragments?

- Not here

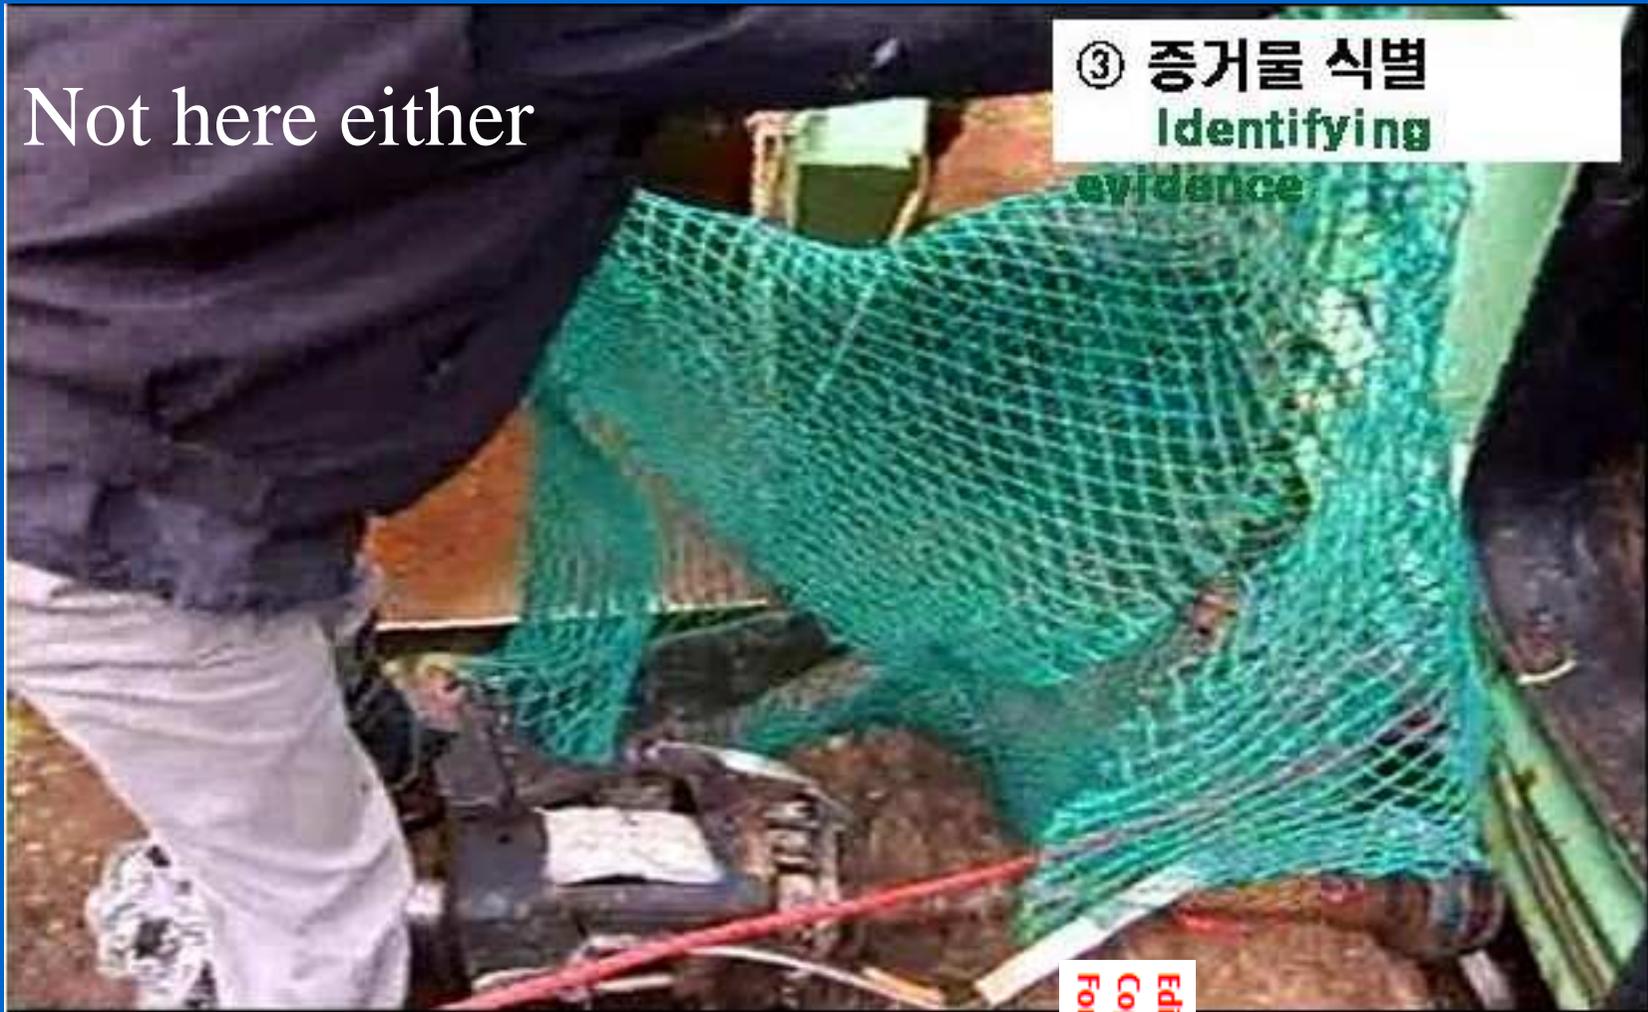
# Where are Fragments?

- Not here either

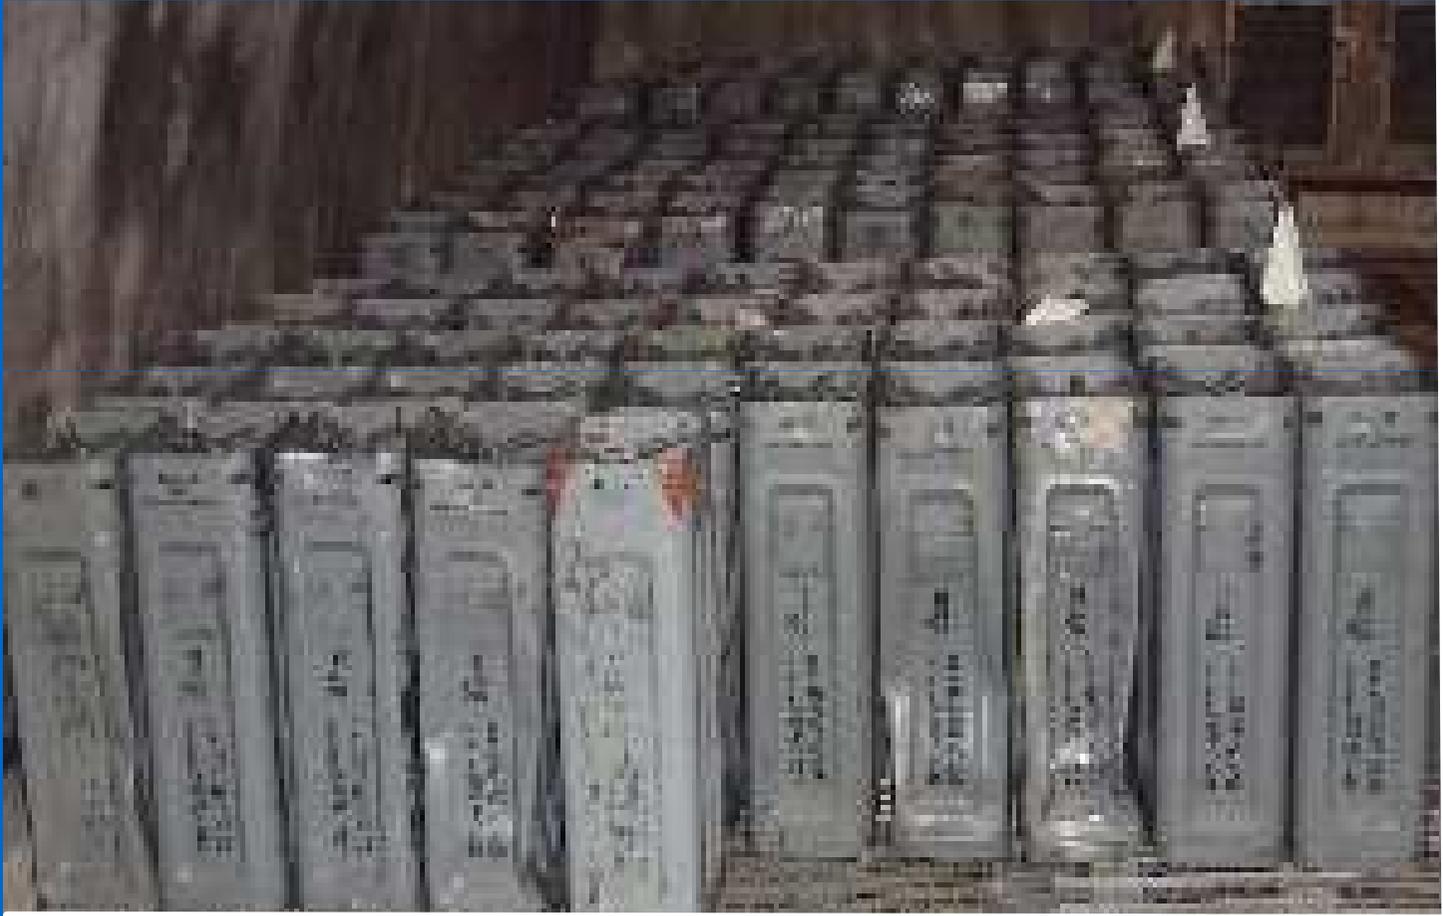
# Secondary Effect of Shock Wave?

40mm 탄약고

40mm Magazine.

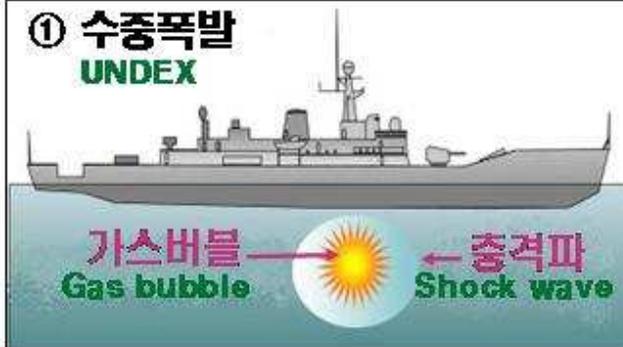
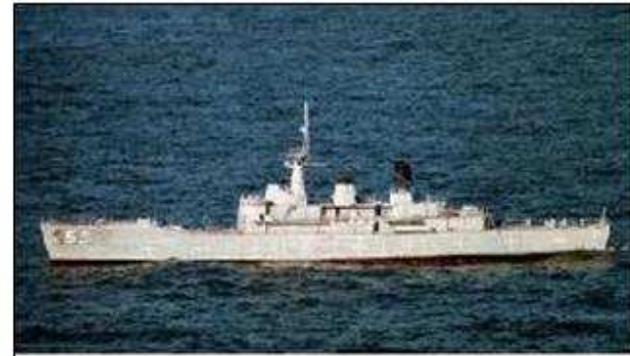
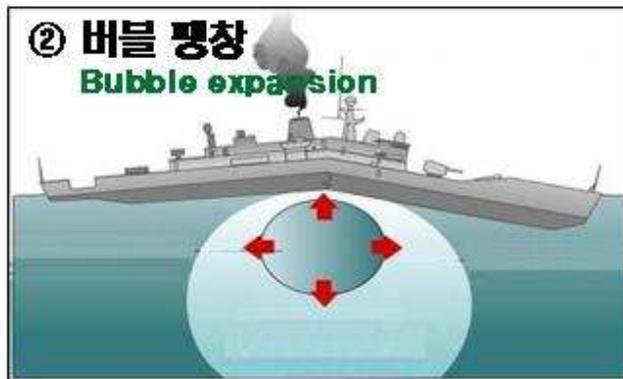
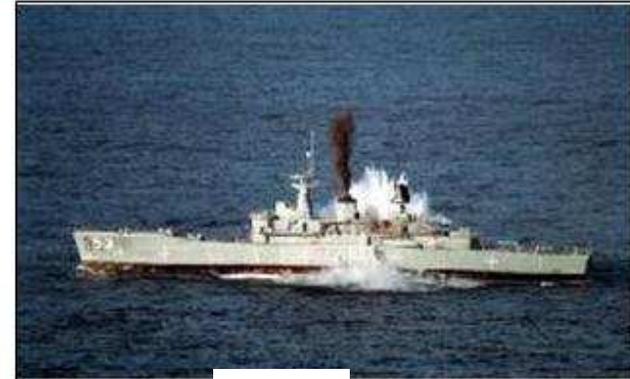
## 버블 진행 과정 [1/3] Bubble Process

### ① 수중폭발 UNDEX

### ② 버블 팽창 Bubble expansion

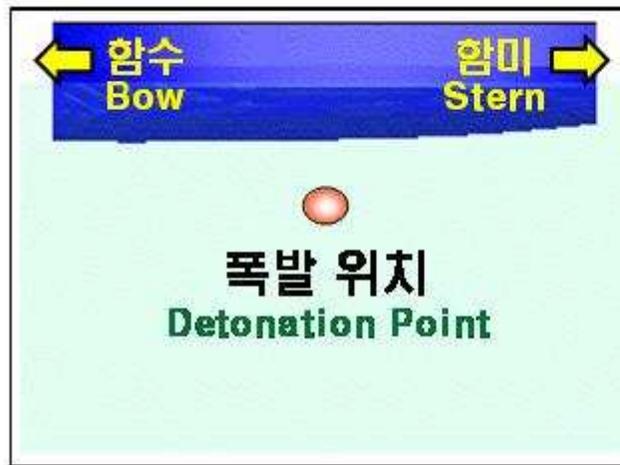
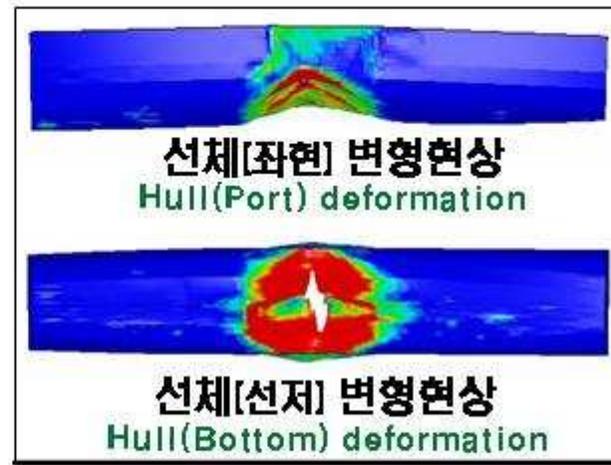
## 시뮬레이션 결과 Simulation Result

가스터빈실 좌현 3m, 수심 6~9m에서  
고성능 폭약 250kg 규모가 폭발시, 천안함 변형현상과 유사  
Explosion of about 250kg high explosive at 6~9m in water  
depth and at 3m to port from center line of gas turbine room  
results in similar deformation as seen on ROKS Cheonan

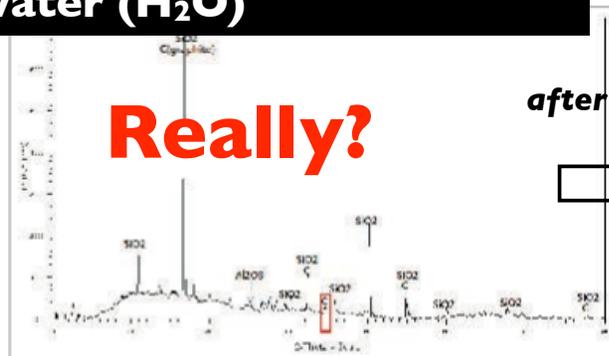
XRD

(Before heat treatment)

after the heating at 1200C

(After heat treatment)

The JIG's interpretation in their final report page 287: "If a crystalline aluminum oxide is found in heat-treated material, in which no crystalline aluminum oxide nor crystalline aluminum was found originally, the (original) material should have an amorphous aluminum oxide as an ingredient in it."
